# DAM CONDITION STUDY

FOR PAGOSA LAKES PROPERTY OWNERS ASSOCIATION

Davis Engineering Service, Inc.

January 15, 2020

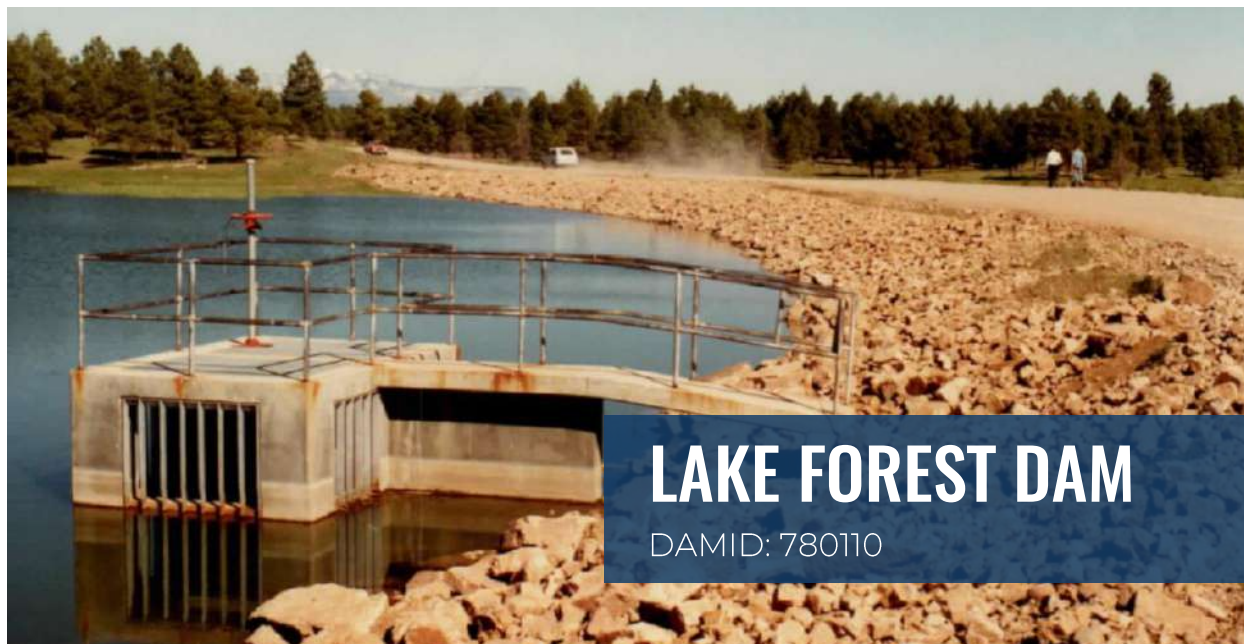
## LAKE FOREST DAM

Lake Forest Dam is PLPOA's smallest in size (height and storage) and has a Low Hazard Classification. Lake Forest Dam is an earthen embankment dam and does not have a traditional emergency overflow spillway. At the maximum section of the dam is a concrete drop inlet structure. This structure has an overflow weir configured at the top, and at the bottom of the structure is a 24-inch diameter ductile iron smooth pipe to serve as a low-level intake. Inside the structure is a sluice gate mounted on the inside wall for control of the water level. The concrete drop inlet structure then discharges into a 72-inch diameter aluminum corrugated pipe that passes through the dam embankment structure.

In reviewing the historical Dam Inspection Reports for Lake Forest Dam, repeated notes were indicated about monitoring the seepage at the downstream toe. Over the years, various rates of seepage have been documented where dam inspectors recommended that seepage rates vs. reservoir storage levels be recorded for monitoring which has not been performed on a planned periodic schedule.

To date, Lake Forest dam is 46 years old (2020-1974). When considering the expected service life of the dam structure components, nearly 46% of the operating service life has been reached for the outlet pipe, 44% for the ductile iron pipe and 92% for the cast-iron sluice gate. The cast-iron sluice gate is nearing the end of its service life and PLPOA is to expect issues (e.g. leaks or onerous operation) in the near future. For the concrete intake structure, the remaining service life is unknown, and it should be monitored and repaired as the concrete condition deteriorates.

**Outlet Works Replacement** – Replacement of the aluminum corrugated outlet pipe, concrete intake structure, and sluice gate. This approach would require partial breach of the dam structure, removal of the roadway surface above the outlet structure and controls. It is important PLPOA plan for this work with PAWSD (stored water user) and Archuleta County (Lake Forest Circle roadway owner) as impacts would be abrupt. Replacement of the outlet structure and controls would restart the operating service life for the replaced structures. Based on the year of Lake Forest Dam being placed into service we estimate this work to take place in 2074.

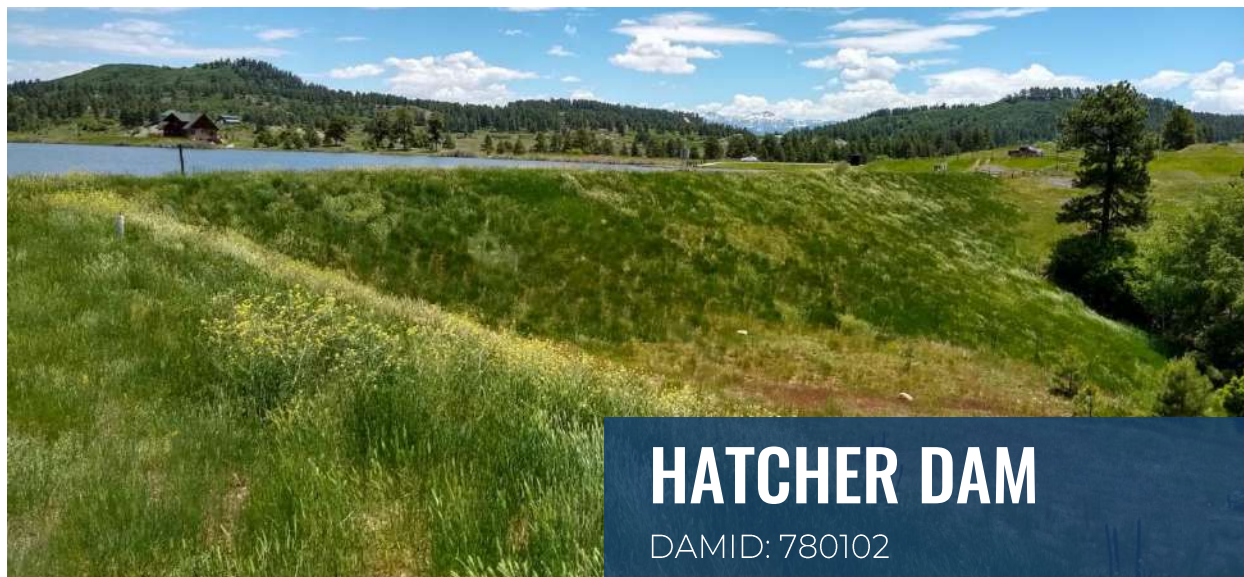
## HATCHER DAM

Hatcher Dam is PLPOA’s largest in size (height and storage) and has a High Hazard Classification. Hatcher Dam is an earthen embankment dam with an emergency overflow spillway. At the maximum section of the dam is a steel slide gate at the intake control structure. The intake control structure then continues through the dam embankment structure by a series of 18-inch diameter reinforced concrete pipes to the outlet headwall.

In reviewing the historical Dam Inspection Reports for Hatcher Dam, repeated notes were indicated about monitoring the seepage at the downstream toe. Over the years varying amounts of seepage have been documented with dam inspectors recommending that seepage rates vs. reservoir storage levels be recorded. Hatcher Dam has had high enough seepage rates to warrant review by an Engineer. In a 1971 dam inspection report a seepage rate was noted as being 0.05 cfs. Repeated high seepage then led to the design and construction of a v-notch weir to quantify and record seepage.

To date, Hatcher Dam is 55 years old (2020-1965). When considering the expected service life of the dam structure components, nearly 55% of the operating service life has been reached for the reinforced concrete outlet pipe and 105% for the steel slide gate. The steel slide gate is at the end of its service life and PLPOA is to expect issues (e.g. leaks or onerous operation) in the near future.

**Outlet Works Replacement** – Replacement of the reinforced concrete pipe outlet, concrete outlet and steel slide gate. This approach would require partial breach of the dam structure. It is important PLPOA plan this work with PAWSD as they use raw water from Hatcher Lake, as it is the primary water source for the Hatcher Water Treatment Plant. Replacement of the outlet works and controls would restart the operating service life for the replaced structures. Based on the year of Hatcher Dam being placed into service we estimate this work to take place in 2065.

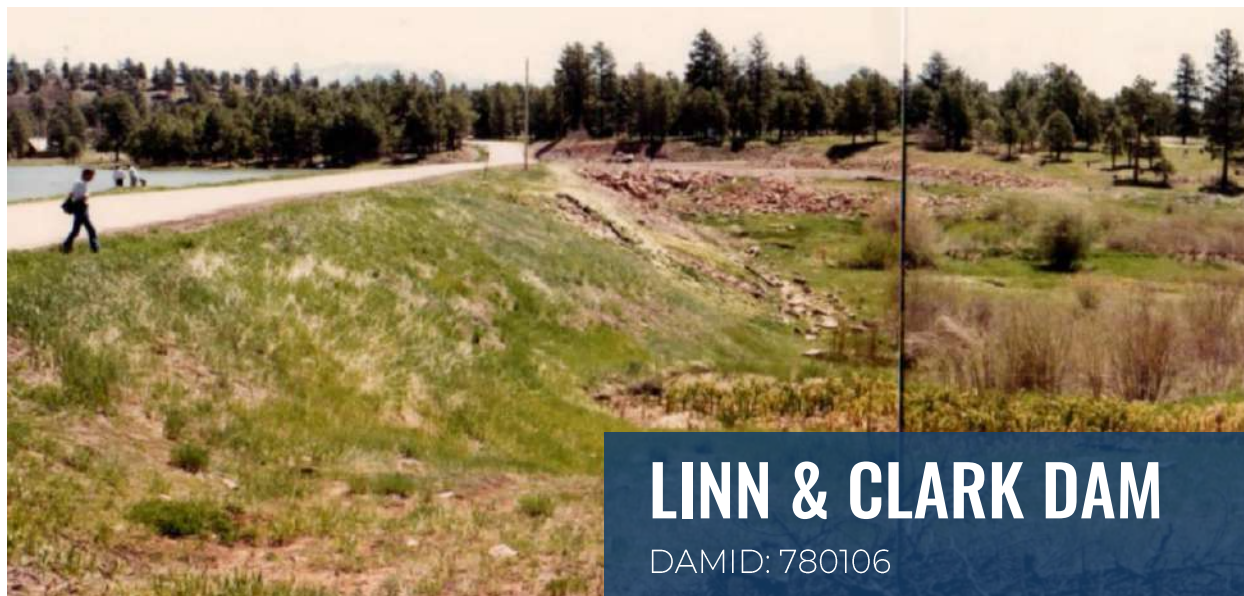
Linn & Clark Dam (or Lake Pagosa) is PLPOA’s oldest and second largest in size (storage) and has a Significant Hazard Classification. Starting in 1902, storage of water in the structure was for a stock pond. No records or information is available on the dam prior to 1971. According to past reports, in 1971 the dam embankment section was enlarged and widened to accommodate a roadway along the crest. Today, the Linn & Clark Dam is an earthen embankment dam with an emergency overflow spillway across Cloud Cap Avenue, with stored water potentially treated for potable use. At the maximum section of the dam is a steel slide gate on the intake control structure. The intake control structure then moves through the dam embankment structure by a series of 24-inch diameter reinforced concrete pipes to the outlet headwall. Also, three high-level culverts are part of the outlet works for the dam structure.

In reviewing the historical Dam Inspection Reports for Linn & Clark Dam, repeated notes were indicated about the boggyness, and inadequate drainage at the downstream toe. Also noted, is a high-level corrugated metal pipe to be properly abandoned or removed from the right side of the dam structure and has not been addressed. We have included an estimated cost for PLPOA to properly abandon the high-level corrugated metal pipe in place.

To date, Linn & Clark Dam is 34 years old (2020-1986). When considering the expected service life of the dam structure components, nearly 34% of the operating service life has been reached for the reinforced concrete outlet pipe and 68% of the operating service life for the steel slide gate. The steel slide gate is past half of its service life and PLPOA should have minimal issues (e.g. leaks or onerous operation) in the future.

**Outlet Works Replacement** – Replacement of the reinforced concrete pipe outlet pipe, concrete intake and steel slide gate controls. This approach would require partial breach of the dam structure. It is important PLPOA plan this work with PAWSD (stored water user) and Archuleta County (Cloud Cap Avenue roadway owner) as impacts would be abrupt. Replacement of the outlet works and controls would restart the operating service life for the structure replaced. This level of replacement work was performed in 1986 and another replacement event would not be expected until 2086. We include within the cost estimate pressure grouting/filling of the existing 15-inch diameter high-level corrugated metal pipe to properly abandon this pipe in place.

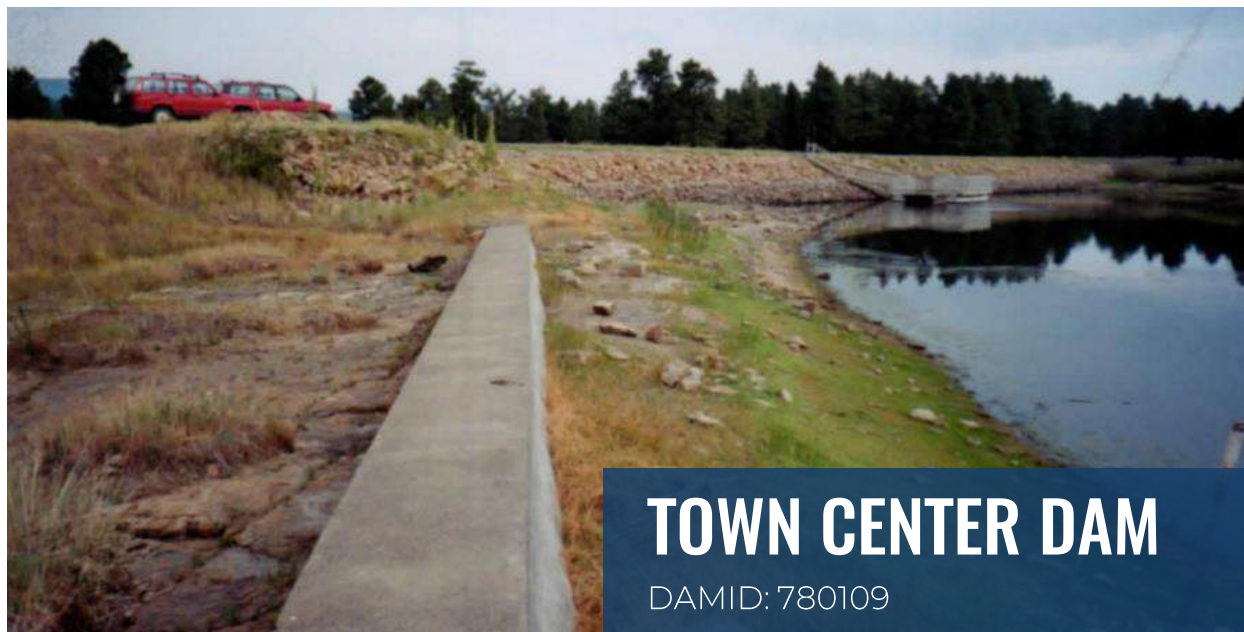
Town Center Dam (or Village Lake) is PLPOA’s third largest in size (storage) and has a Significant Hazard Classification. Town Center Dam is an earthen embankment dam with an emergency overflow spillway below North Pagosa Boulevard. At the maximum section of the dam is a steel sluice gate at the intake control structure. The intake control structure then continues through the dam embankment structure by a concrete encased 24-inch diameter CMP to the outlet headwall. Recent rehabilitation work was performed to add a cured in-place pipe (CIPP) liner material inside the corroded 24-inch diameter CMP.

In reviewing the historical Dam Inspection Reports for the Town Center Dam, repeated notes were indicated about seepage at the downstream toe. Recommendations by dam inspectors have been made to install a v-notch weir to quantify discharge for seepage monitoring which has not been completed. To date the drain outlets have not been located to monitor seepage amounts.

To date, Town Center Dam is 47 years old (2020-1973). When considering the expected service life of the dam structure components, nearly 47% of the operating service life has been reached for the reinforced concrete outlet pipe and 94% of the operating service life for the steel sluice gate. The steel sluice gate is at the end of its service life and PLPOA is to expect issues (e.g. leaks or onerous operation) in the near future.

**Outlet Works Replacement** – Replacement of the concrete encased 24-inch diameter CMP outlet pipe, concrete intake and steel slide gate controls. This approach would require partial breach of the dam structure. It is important PLPOA plan this work with PAWSD (stored water user) and Archuleta County (North Pagosa Boulevard roadway owner) as impacts would be abrupt. Replacement of the outlet works and controls would restart the operating service life for the replaced structures. If protection of the 24-inch diameter CMP is successful in the future with the CIPP liner then we would expect replacement of the outlet structure to be delayed. Maintenance in the form of protecting existing infrastructure lengthens the service life of dam appurtenances. Based on the year of Town Center Dam being placed into service we estimate this work to take place in 2073.
